Manhole Inspection Summary

Manhole # S29MM1003MH

Insp Date: **10/14/08 12:20 PM**

Location Address: **LINKWOOD RD**

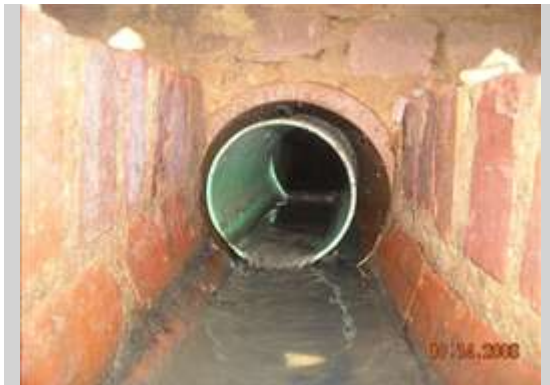
8 in. Circular Gravity Sewer Pipe In @ 7 O'Clock

Pipe Material: **PVC** ☐ Pipe Lined

Infiltration: **None** Pipe Seal Cond: **Unknown**
